**Utilities Commission
City of New Smyrna Beach, Florida**

**Assessment of Existing Reciprocating
Electrical Generation Equipment
- Final Report -**

**Smith Street and Swoope
Generating Facilities
(Project No. 306.021)**

July 29, 2011

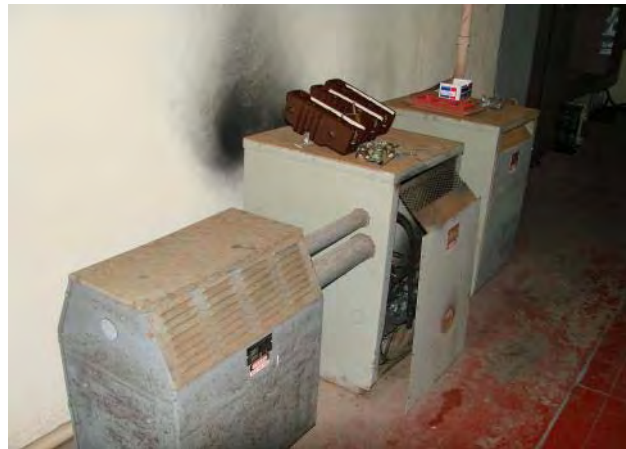
typical of that era. Certainly, this equipment suffers from the effects of insulation deterioration and corrosion due to years of exposure to the moist, humid, and salty atmosphere. We have had the opportunity to work with a number of clients that had equipment of similar age and condition. The likelihood of periodic component failures is high. In fact, this has already occurred as evidenced by the carbon deposits shown in the adjacent photo.

DAI has concern that the continued operation of this type of equipment may present some potential hazards to UCNSB personnel during its use. These panels are not a current design which affords operators protection from arc flash. The existing UCNSB gear can be dangerous and present potentially greater and greater hazards the longer it remains available for use. Because both buildings are completely open, the panels and switchgear are exposed to temperature changes, high humidity, dust, and possible infestation of vermin. These conditions are not conducive to the safe, reliable, and extended operation of this type of equipment.

Modern, new metal-clad switchgear, panels, relays, and controls can be purchased and installed for any of the engine generators. It is costly, but it would offer the protection safeguards, reliable operation, and functionality needed for an operating utility. In our evaluation of each engine, budgetary costs for new replacement electrical gear have been included. However, it should be noted that this equipment must be

installed in a temperature and humidity controlled room, not in an open facility as it is now. To do otherwise would be ill-advised.

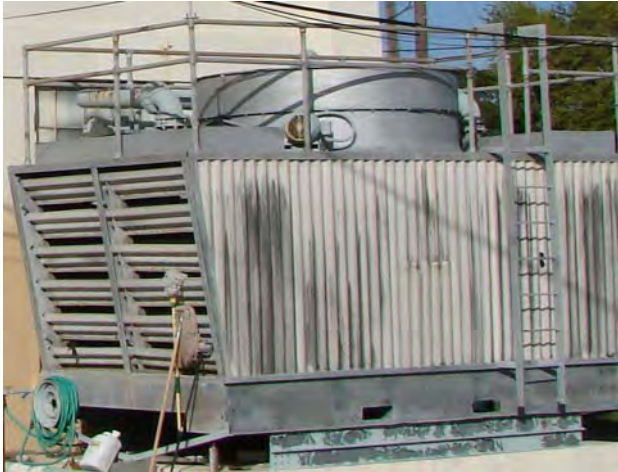
The cooling unit for this engine (shown in photo) which is located near the main overhead door on the side of the building opposite all other cooling units, generally seems to be in usable condition. No indication of the age, but it seemed to be in better condition than the cooling units for the remaining four engines in this building. It does not show the obvious signs of corrosion and perforations in the outer panels as is apparent on other cooling units at this site. But since this engine has not operated for a number of years, some amount of maintenance and repairs can and should be expected before restarting.

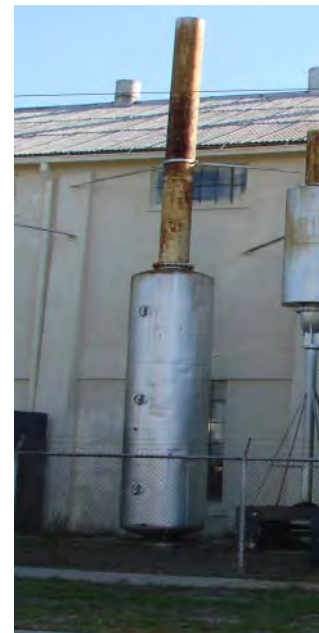
The exhaust silencer for Engine #3 (shown in the center of the adjacent photo) is a flange-mounted unit, fed from a pipe located below the power plant floor elevation. This unit is unique in this feature. The lower flange where the base of the silencer is mounted is located on a small concrete pad along the exterior of the power plant building wall.

The condition of the exhaust silencer unit for this engine is thought to be typical of the other units located at this facility. Though the main body of the unit has been repainted in recent years, through age and lack of use, it has likely succumbed to the deterioration and corrosion caused by the constant exposure to the moist, salty atmosphere. A few significant areas of rust were apparent, especially near the base of the unit. Surface ripples or an otherwise non-smooth appearance of the outer shell of the main body of an exhaust silencer is an indicator of the weakening of the unit attributable to inner corrosion. Observations indicate this condition is evident here.

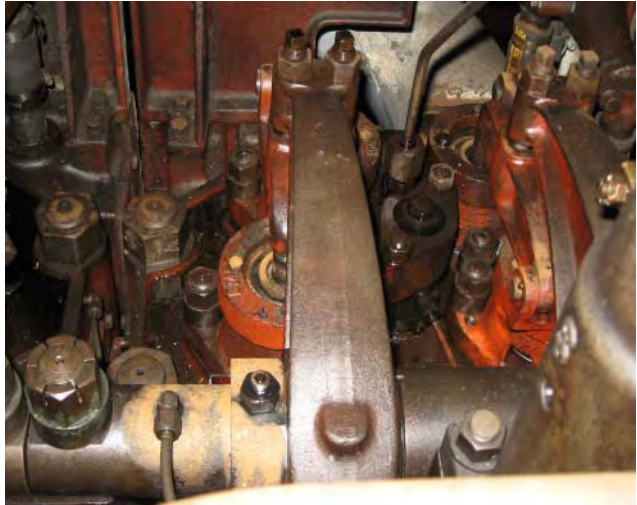
Discussion: Without the benefit of any engine diagnostic tests, we can only speculate as the internal condition of this engine and its components. However, this particular engine has valve cover panels that are easily removed, providing access to the rocker arms, injectors, cam followers, and the individual engine heads. Engine oil is pumped into this part of the engine at high volume and very low pressure to essentially flood these components with lubricant during operation. During our visit, UCNSB maintenance staff removed some of these access panels. There was no evidence of any sludge, or apparent excessive component wear (see photo insert); overall this area was extremely clean. It seems this engine was well maintained during its years of operation.

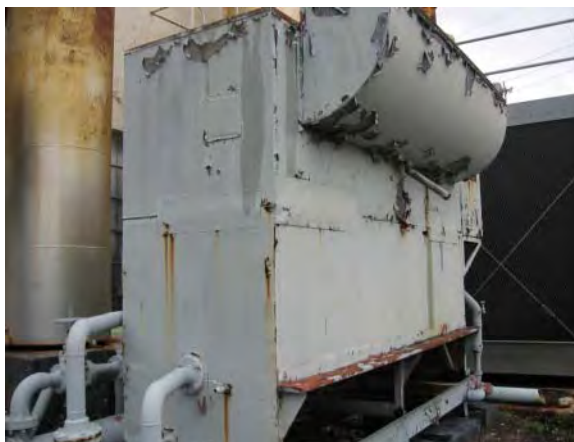
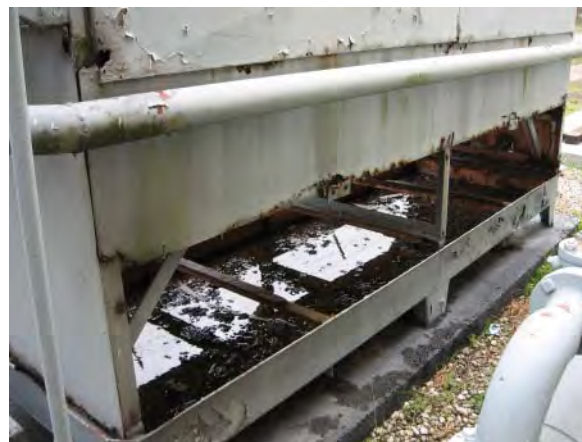
According to the maintenance staff at UCNSB, the particular cooling unit for Engine #4 is apparently not in working condition. (Photos of this unit are shown below.) Though the outside panels appear largely intact, (some rust and peeling paint), the inner parts are apparently corroded to the point where the unit can no longer properly function. Observations while on site seem to support this assessment. Without a functioning cooling unit, this engine cannot be started and run at all, regardless of the condition of the engine itself.

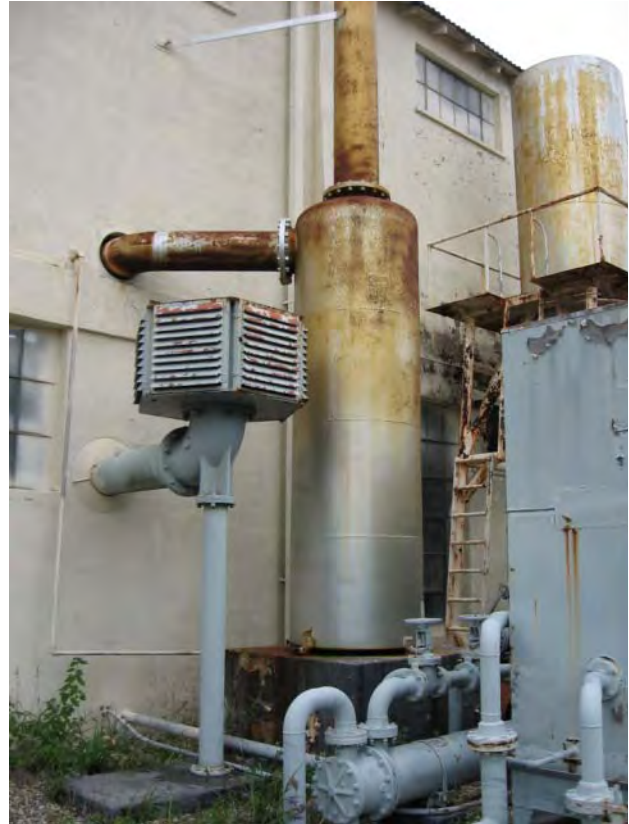
The reported condition of the exhaust silencer is also poor. As can be seen in the photo, this unit rests on an elevated concrete base with a high inlet pipe. The unit shows evidence of significant rust and possible perforations at the bottom section. Given the fact this engine has not run for several years, there is nothing to prevent water from settling in the bottom of the silencer unit and corroding the base and inner components. As was the case for the cooling unit, the condition of this component itself would prevent this engine from being operated safely and effectively. With a non-functioning cooling unit and a rusted silencer with possible perforations, it is completely understandable why this unit has not been started and run in several years. To start this unit under these conditions would be ill-advised.

Associated with this engine is also a unique external air intake unit. This is also shown in the photo. The condition of this unit is somewhat questionable given the overall appearance. The simplicity of the unit should allow it to continue to function, but its outward appearance gives further evidence of a need for replacement and/or upgraded components should this engine need to operate in the future.

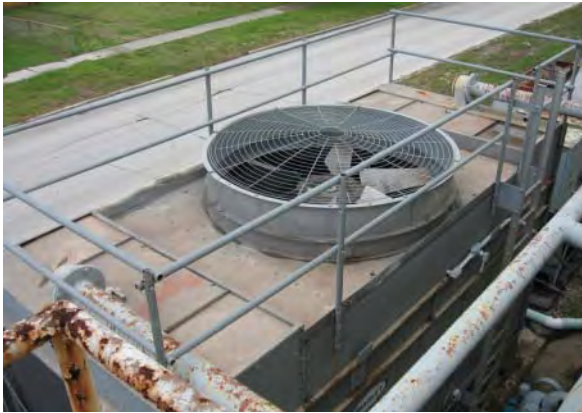
However, the ancillary equipment needed to run this unit safely and effectively is definitely not in a state of readiness. The cooling unit for this engine is reported to be in very bad condition, suffering from the effects of considerable internal corrosion. This particular one is a Marley brand cooling unit and is shown in the adjacent photo. Similar to other units at this site, it still looks intact externally, but the base water collection areas as well as some of the upper components indicate a condition of severe

rust buildup. This condition would prohibit an effective and sufficient circulation of the cooling water to and from the engine during operation.

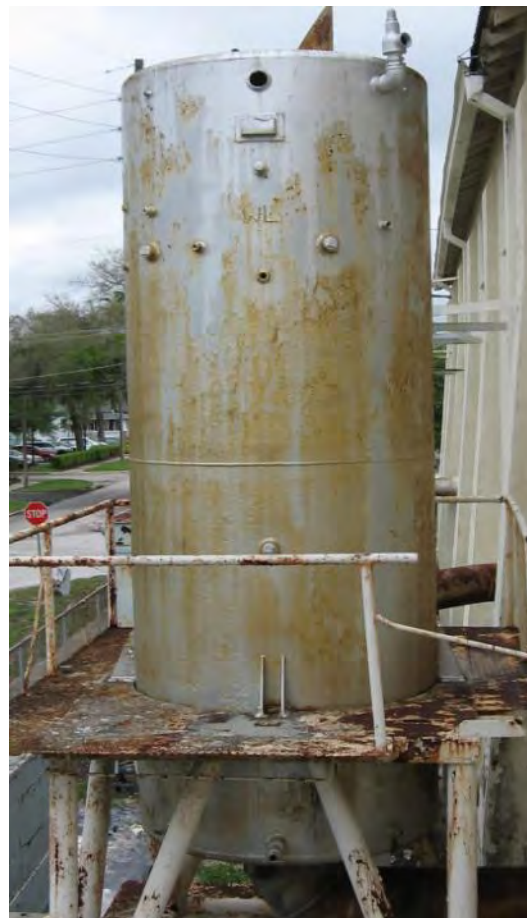
In a similar manner, it seems the exhaust silencer for this engine also suffers from a significant amount of rust and deterioration. In particular, the inlet pipe and elbow that extend into the lower part of the silencer unit exhibit severe corrosion. The platform and support stand surrounding the unit are extremely rusted, and the tail pipe that normally extends from the top of the unit is missing completely. UCNSB maintenance staff report this silencer to be in very poor condition. No doubt, the internal condition of this unit has been severely compromised due to the presence of rainwater and moisture for long periods of time.

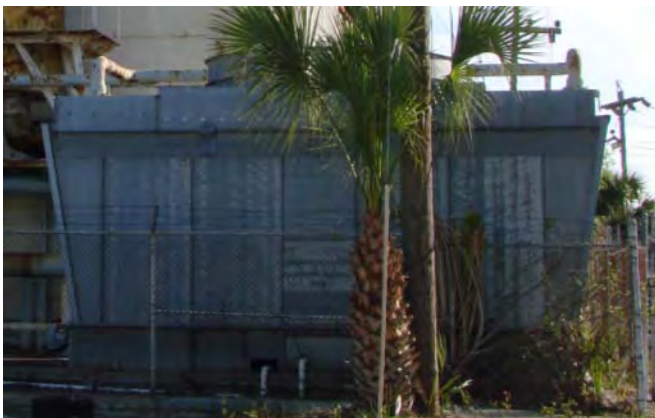
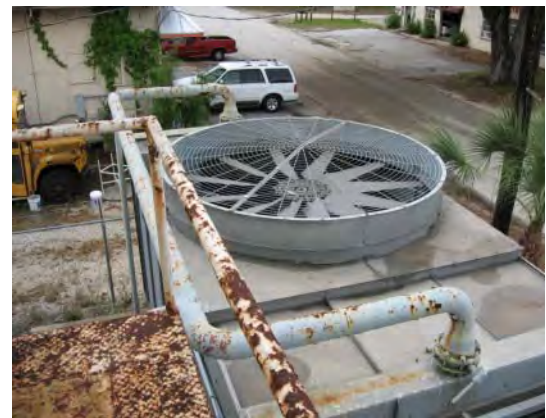
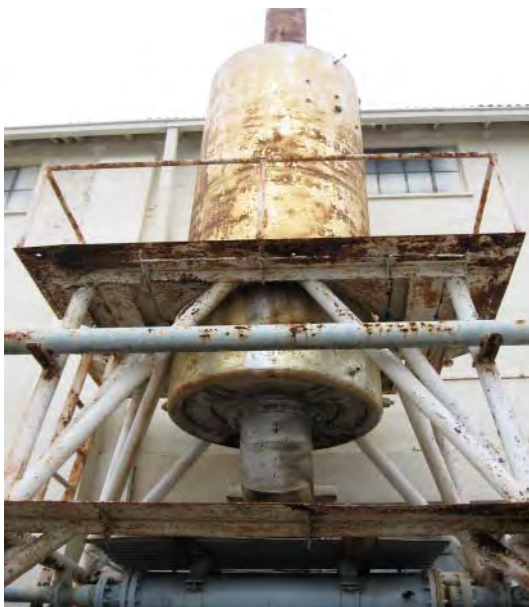
But as was the case for the other Enterprise engine, the condition of the ancillary equipment in place for Engine #7 would essentially prohibit the operation of this engine even if the attached generator was in good working condition. The cooling unit for this engine is reportedly in very poor condition, highly corroded and rusted internally from decades of exposure to water and the coastal environment (Photos of this Marley brand cooling unit are shown below). The unit also exhibits the effects of lack of use for a lengthy period of time with vegetation growth evident at one end of the tower air inlet.

Likewise the exhaust silencer for Engine #7 exhibits the effects of long-term exposure to the salty, moist environment. Apparently, it was painted some time ago, but the rust on the outer shell has bled through the coating of paint. Though this rust may be severe, it is not the essential problem. According to UCNSB maintenance personnel, the inside of this silencer is full of rust debris. We did not see any perforations in the outer shell, but have little reason to doubt their assessment. Also, as was the case for the adjacent Enterprise engine, the tower and stand for this exhaust silencer are heavily corroded as a result of years of exposure.

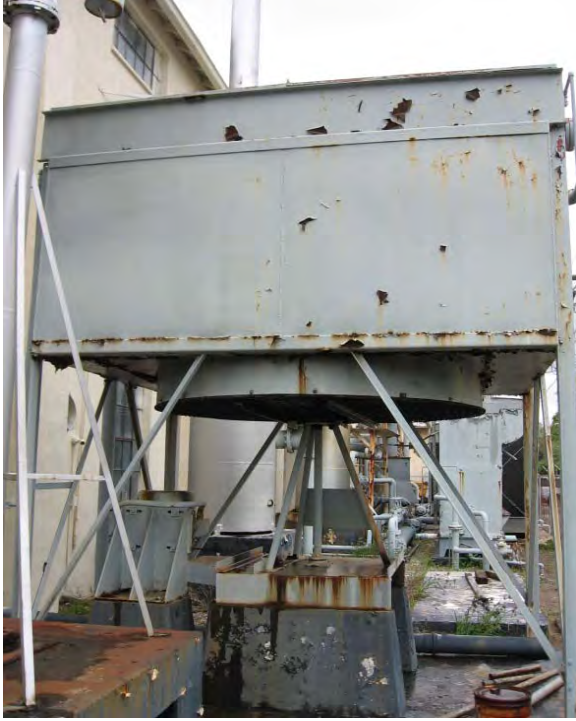
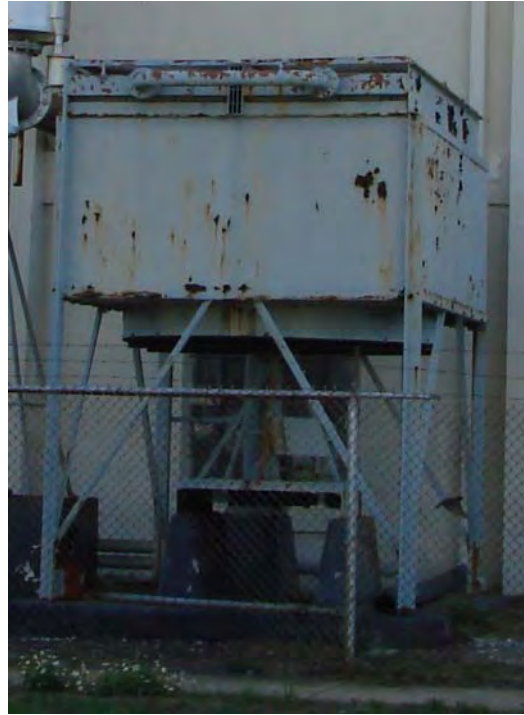
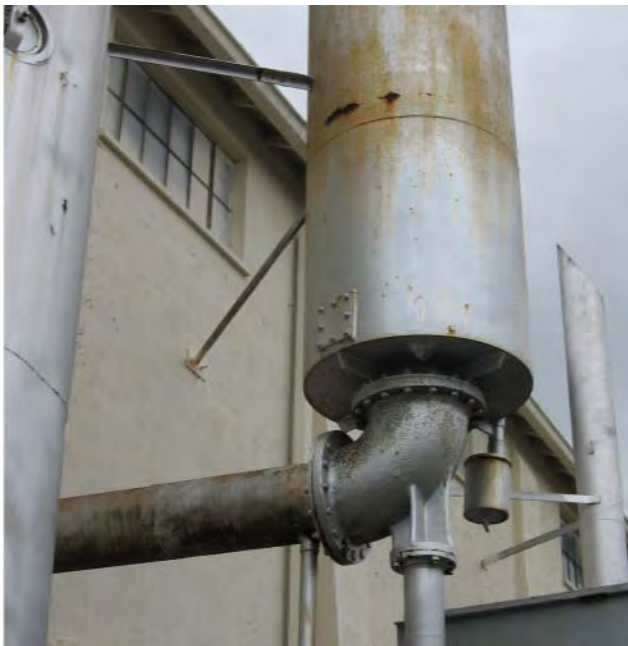
This engine is presently equipped with a radiator cooling unit (shown in the following photos) that is reported to be in poor condition. Outwardly, the condition is marginal; on the inside and underneath it is quite rusted. UCNSB staff reported engine overheating requiring shutdown during the last run, (and that may have been several years ago). It seems clear that this unit too has succumbed to the combined effects of age and exposure.

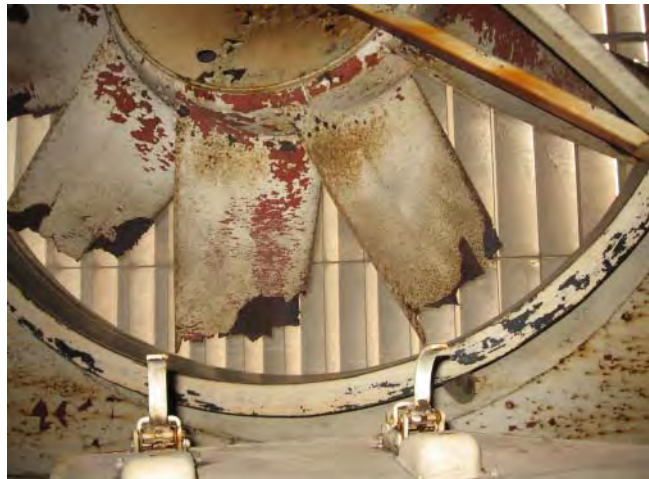
Discussion: Having been rebuilt within the past 25 years or so and under the presumption of minimal runtime during the past several years, there is no reason to conclude this engine is not in good, sound operating condition. That stated, we were made aware of the fact that there are at least two issues with this unit that prevent it from running if needed. First, the cooling fan sustained considerable damage during operation sometime in the recent past. As a result of some incident which is not fully understood, some of the fan blades were severely damaged during operation and remain so at the present time, (see photo). The damage has rendered this unit inoperable until and unless the fan is replaced.

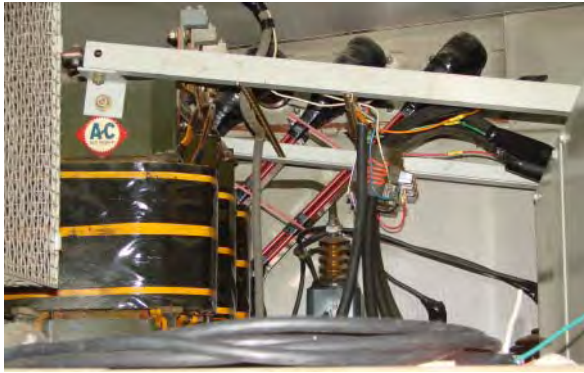
Also during our visit, we have learned that a main dry-type transformer for the electrical switchgear servicing the entire group of three EMDs has failed. (Unit is shown in adjacent photo.) As a result, no power can be delivered from this EMD unit or any of the other two engines even if they could be operated. So though the engine would be capable of starting and running otherwise, the problems associated with these two components have effectively taken this engine out of service for the foreseeable future. UCNSB staff has given no indication as to when or more

importantly if either of these two problems will be corrected.

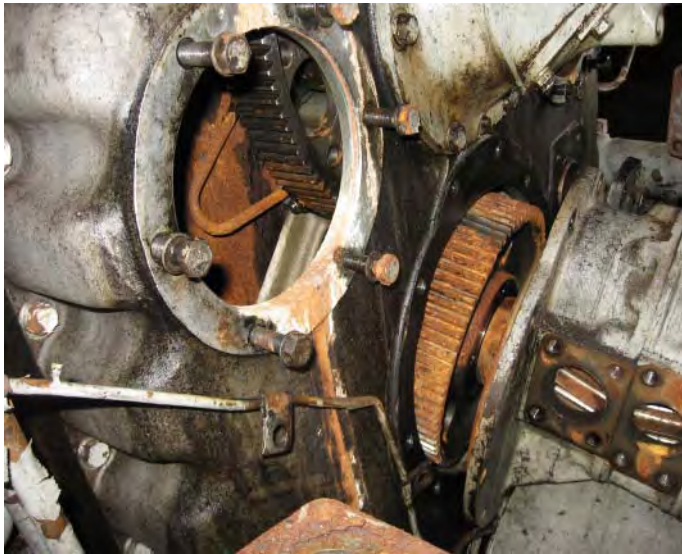
Description: Engine manufactured by the Electro-Motive Diesel division of GM. This unit is a 16 cylinder model with turbo, approximately 2800 Bhp at 720 RPM. UCNSB classifies this engine as a “peaking unit.” It is fully contained in a stand-alone enclosure which houses the engine-generator, a fan-cooled radiator unit, air intake, and a shrouded overhead exhaust silencer. This unit is capable of remote start. Three unsuccessful attempts result in a system control fault, disabling the remote start feature. Apparently, some time ago, this engine seized during a startup sequence. UCNSB main-

tenance staff began to disassemble the engine to determine the problem and presumably to make the needed repairs. During our visit, we found the valve covers off of one side of the engine, heads removed from the other, a main pump drive detached (see photo), and the shrouding removed from the exhaust manifold. For reasons not entirely understood, work on this unit was suspended and has not resumed. Facility operating records indicate no runtime for at least the previous five years. The condition of the generator for this unit is reported to be good.

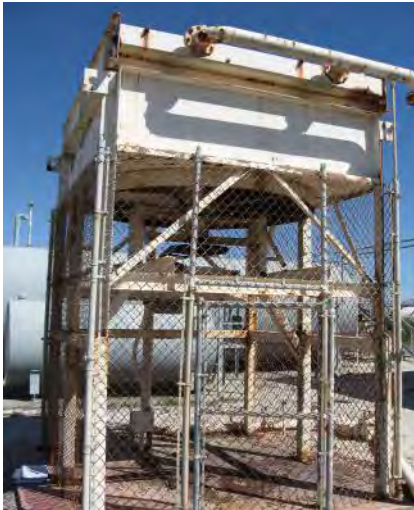
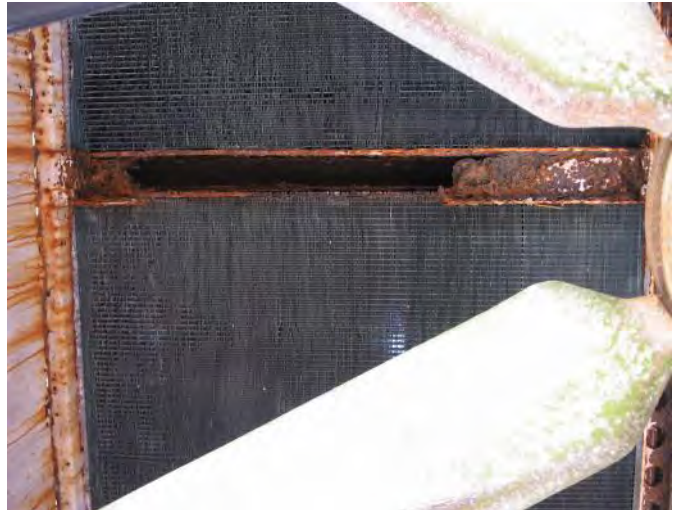
less than those at the Smith Street facility, the environment at Swoope is probably more severe due to the closer proximity to the ocean. Obviously, the condition of this cooling unit has effectively rendered this engine inoperable.

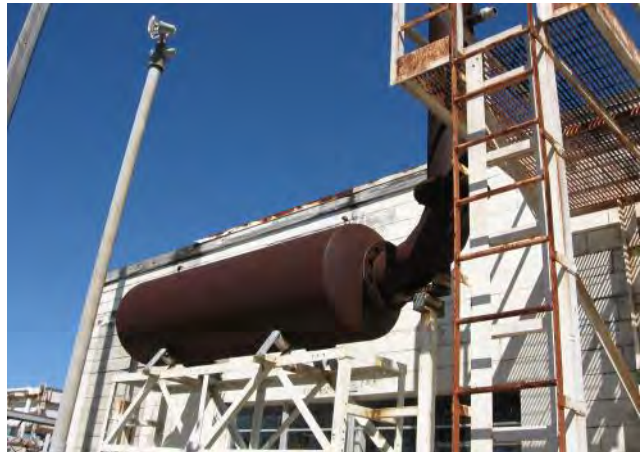
The exhaust silencer attached to this engine appears to be in fair condition. It bears the outward coating of rust typical of a used silencer, but no perforations were evident. The inlet and outlet pipes seemed to be sound and securely in place. Certainly, one would expect to find some amount of internal corrosion due to the collection of rainwater, but it does not seem to have reached to point whereby this component requires replacement prior to starting and running this engine again. However, RICE NESHAP would mandate replacement prior to placing this engine back into service.

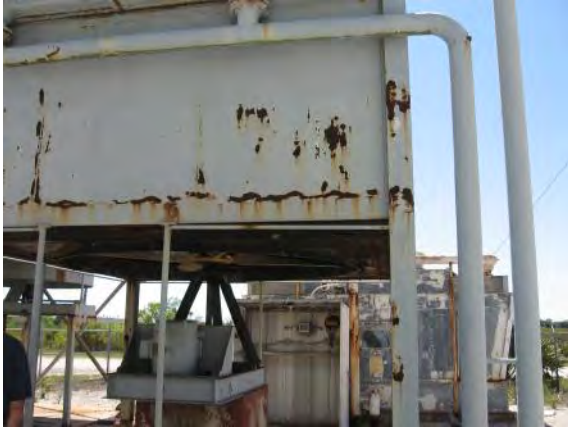
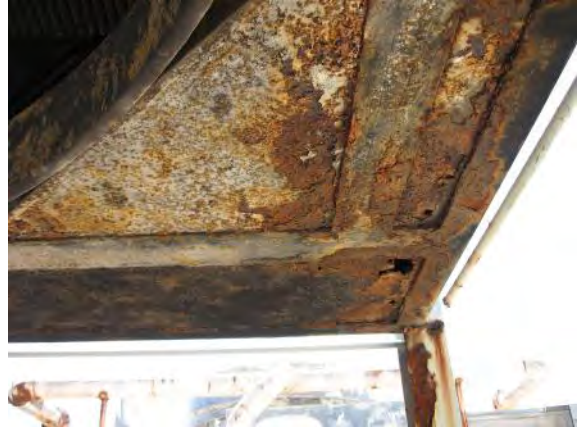
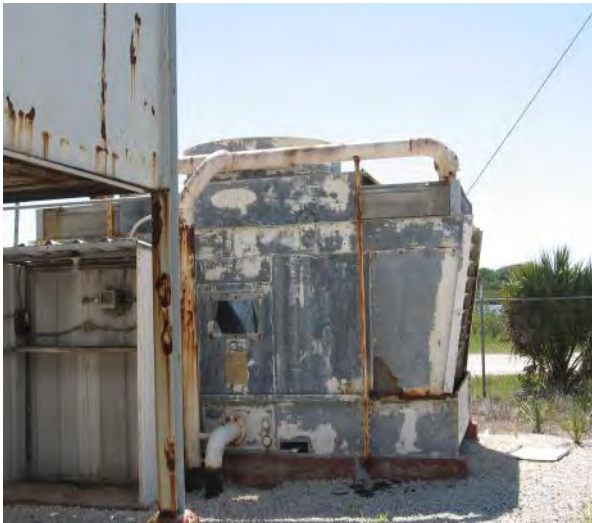
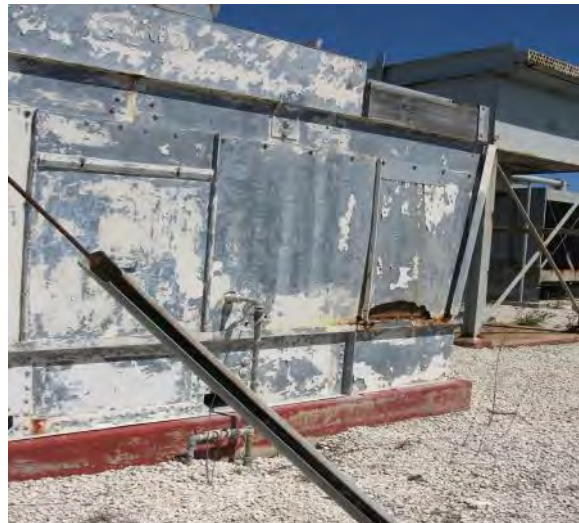
current condition of this equipment is clearly not conducive to allow extended runs of this engine and both will require replacement in order to allow this unit to run reliably in the future.

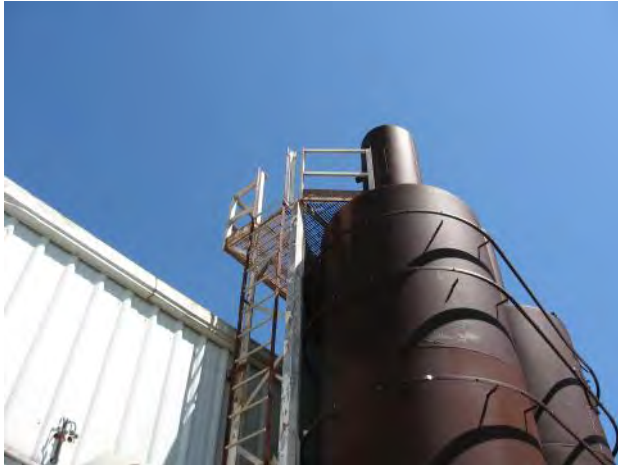
The exhaust silencer for Engine #3 seems to be in reasonably good condition. It is a large, ground-

mounted unit with a complete platform and ladder assembly in place for conducting stack tests (shown in photo). The outer bands at one time served as mounting for a heat shield. Apparently part of this shield was removed to make some repairs to the outer shell of the silencer for Engine #4. This work was performed at the time of the last stack test some five years earlier. More of the shielding was blown off during a storm or perhaps a recent hurricane.

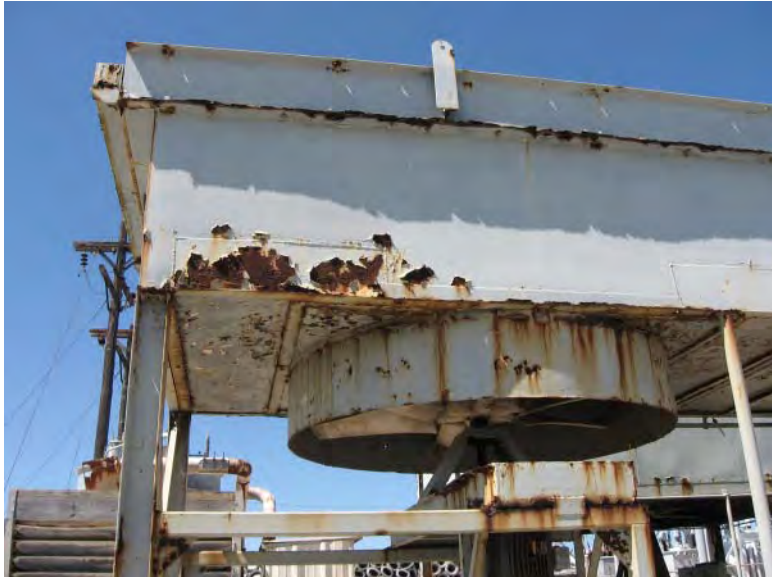
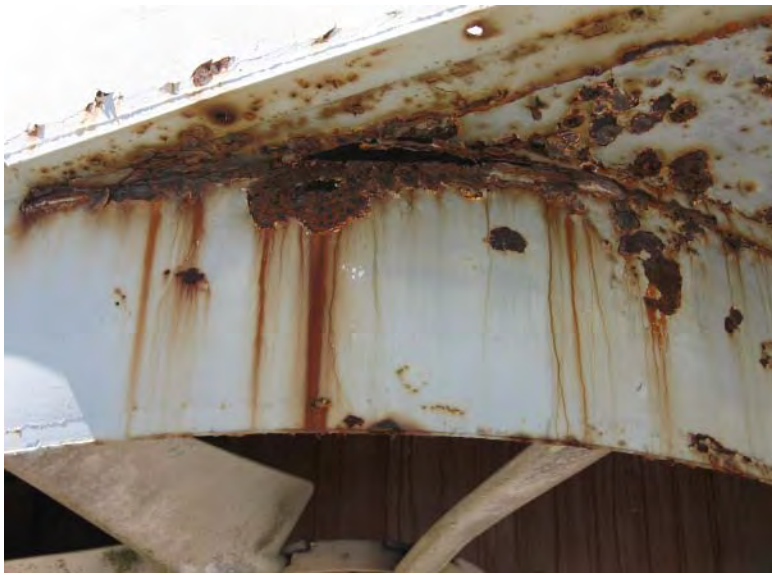
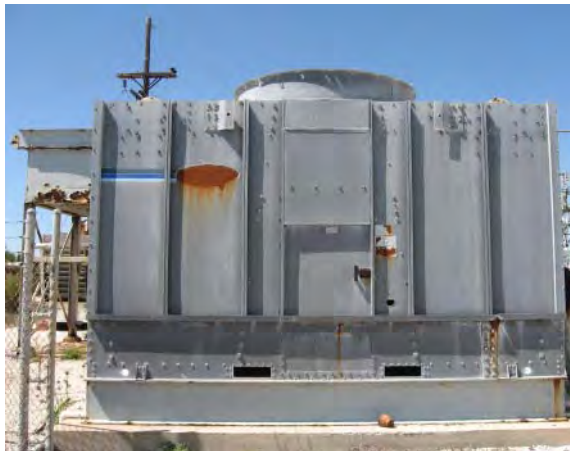
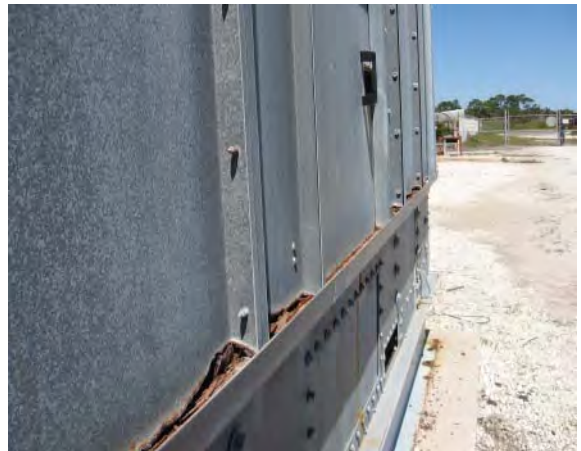
But similar to other units at this facility and at Smith Street, the condition of the ancillary equipment does not allow this engine to be operated as often or as reliably as may be desired or required. As with Engine #3, there are two cooling units tied to this engine, a radiator and a separate cooling tower. Unfortunately, neither of these units is in particularly good condition. The radiator panels are severely rusted with some noticeable perforations. The cooling tower may be in a little better condition, but it too is questionable (see photos on following page). Clearly this environment so close to the ocean has resulted in the deterioration of this equipment. It seems evident that both of these units should be replaced soon if this engine-generator is needed in the future for reliable service.

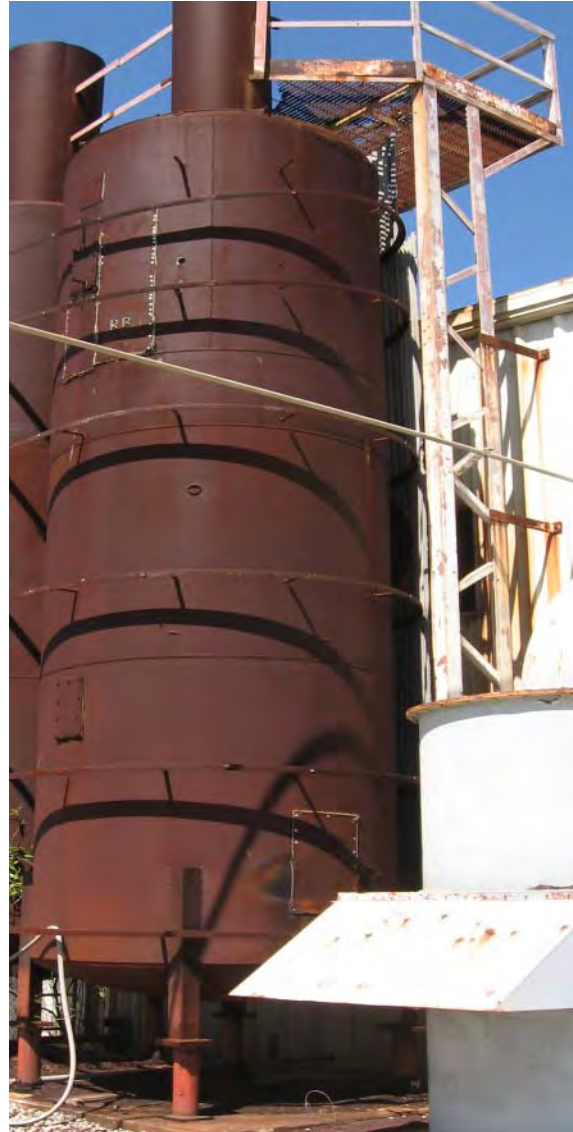
The exhaust silencer for this engine is a large, ground-mounted unit with a complete testing platform installed (see photo). The outer bands at one time served as mounting for a heat shield. Apparently part of this shield was removed to make some repairs to the outer shell of the silencer as evidenced by the patches. This work was performed at the time of the last stack test some five years earlier. More of the shielding was blown off during a storm or perhaps a recent hurricane.

Other than the patches, at first glance this unit appeared to be in fairly good condition. However, this is apparently not the case. According to UCNSB maintenance staff, there is a considerable amount of rust buildup inside the unit. The concrete pad on which the unit rests was thoroughly coated with significant amount of rust debris.
