## **LOGAN DIVING & SALVAGE**

### **UNDERWATER INVESTIGATION INTRACOASTAL WATERWAY AND CALLALISA CREEK SUBAQUEOUS CROSSINGS For UTILITIES COMMISSION NEW SMYRNA BEACH**

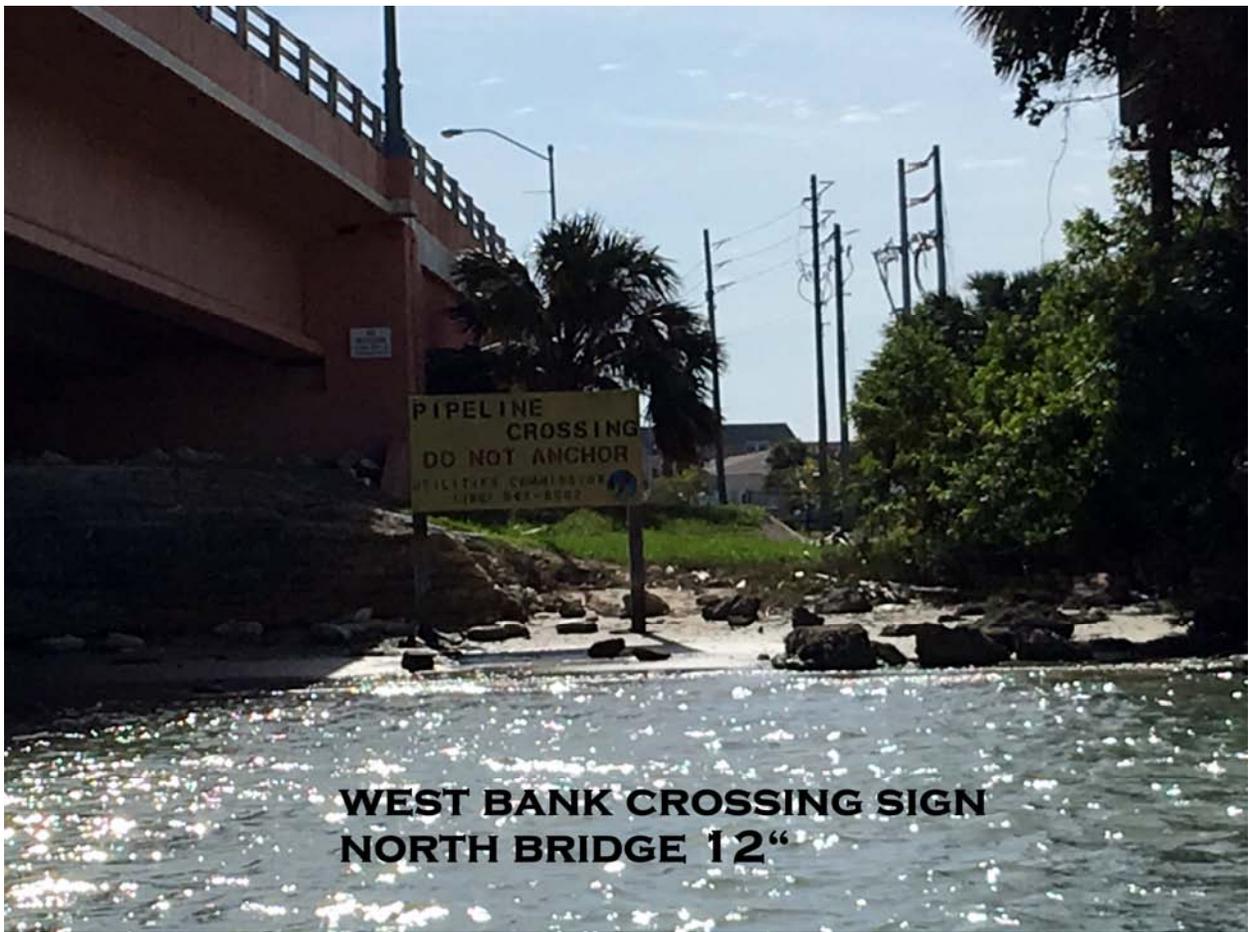
CROSSING SIGNS ARE IN PLACE AND SERVICEABLE.

**WEST BANK CROSSING SIGN  
NORTH BRIDGE 12"**

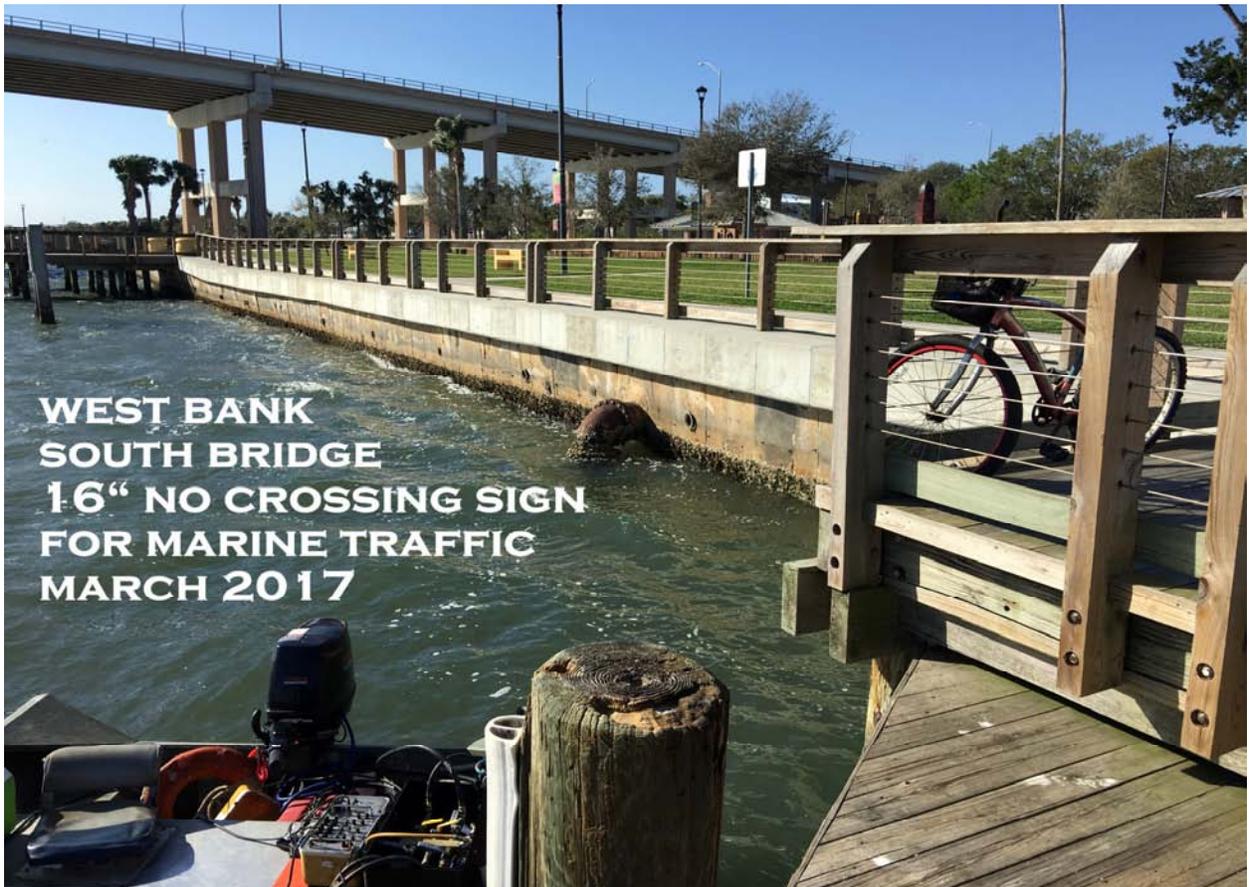
BOTH THE 16" AND 8" CROSSINGS REQUIRE CROSSING SIGNS.

**WEST BANK  
SOUTH BRIDGE  
1.6" NO CROSSING SIGN  
FOR MARINE TRAFFIC  
MARCH 2017**

- 4) INSTALL CROSSING SIGNS ON BOTH SHORES, BOTH CROSSINGS.

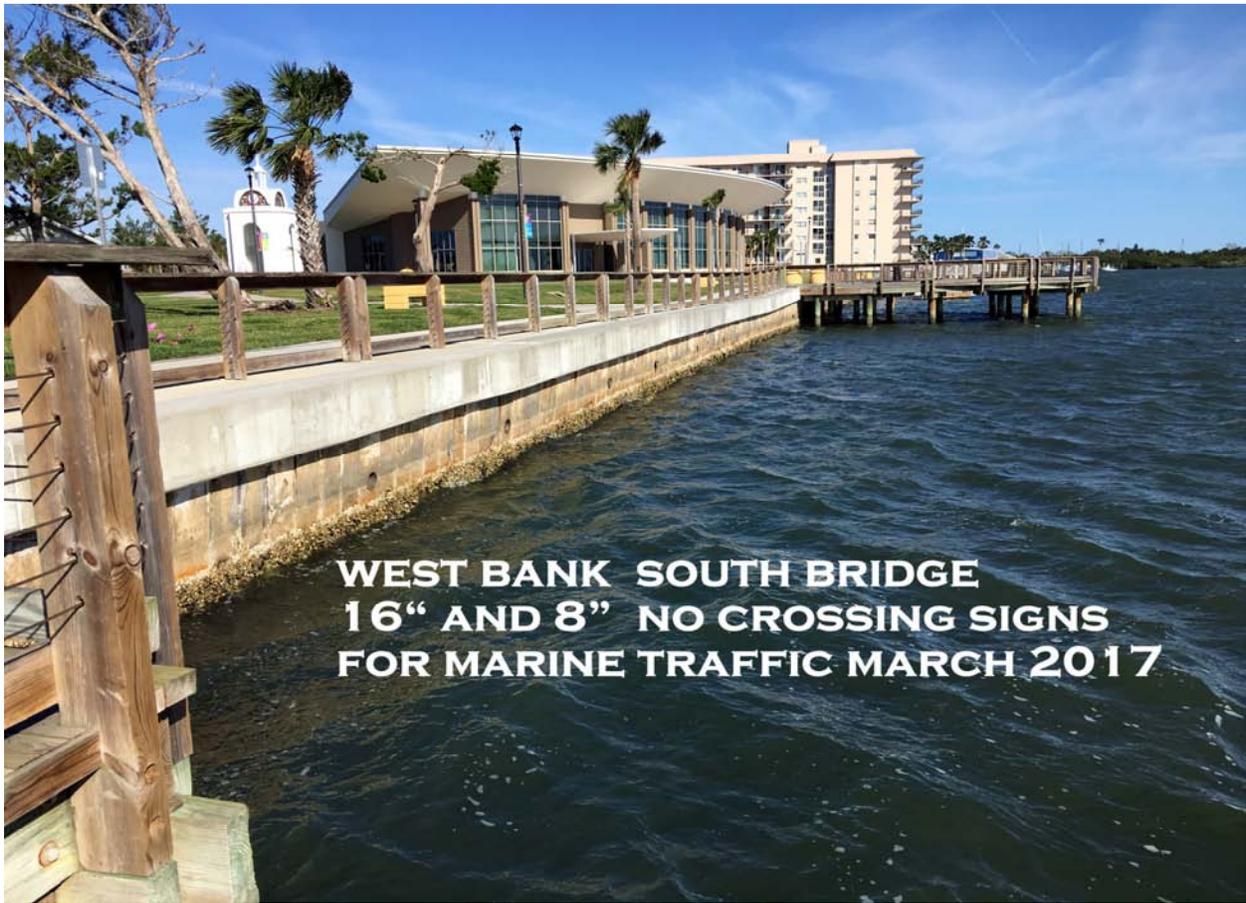
**WEST BANK SOUTH BRIDGE  
16" AND 8" NO CROSSING SIGNS  
FOR MARINE TRAFFIC MARCH 2017**

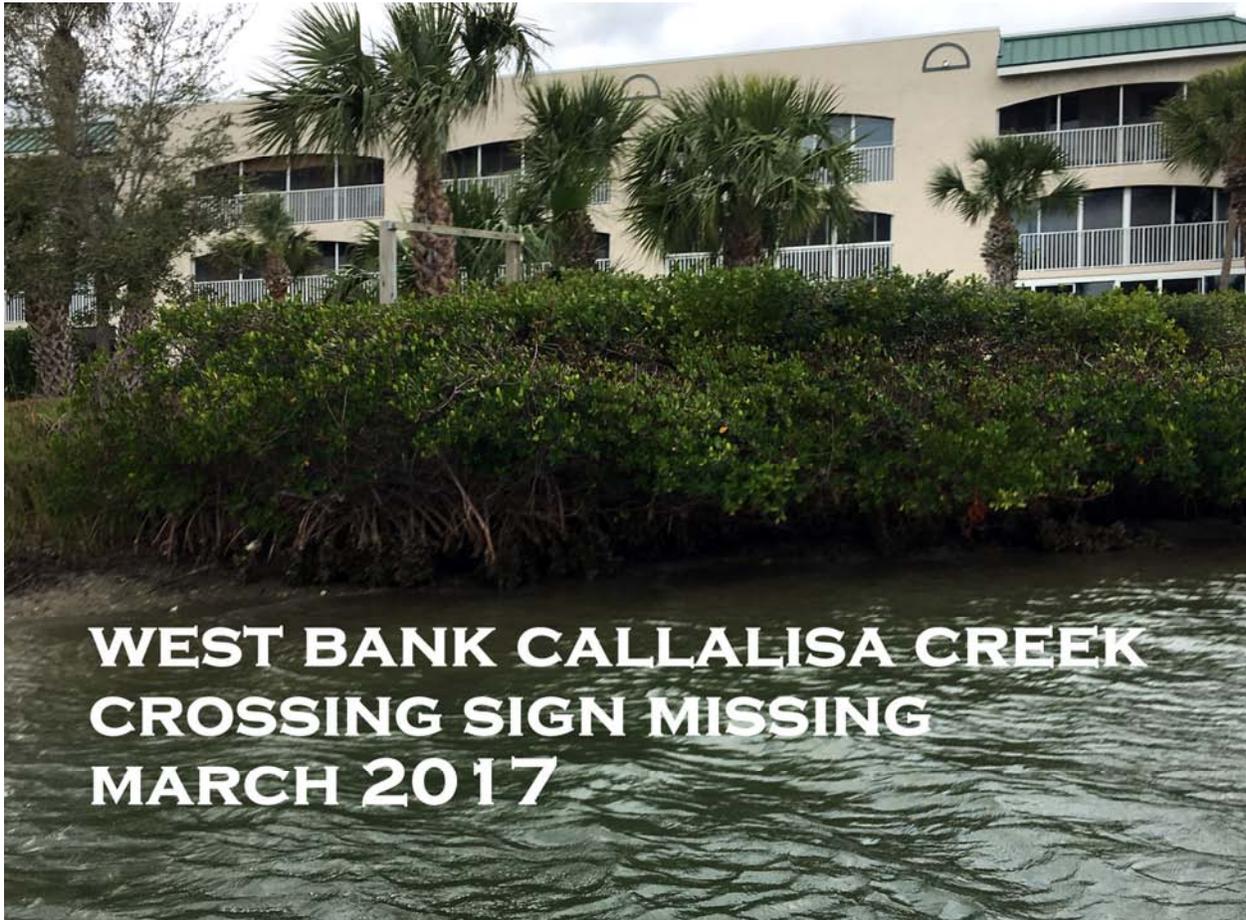
WEST BANK CROSSING SIGN IS MISSING, EAST BANK OBSCURED BY TREES.

**WEST BANK CALLALISA CREEK  
CROSSING SIGN MISSING  
MARCH 2017**

- 5) REPLACE WEST BANK CROSSING SIGN.
- 6) EAST SIGN OBSCURED BY TREES, REMOVE OVER GROWTH.

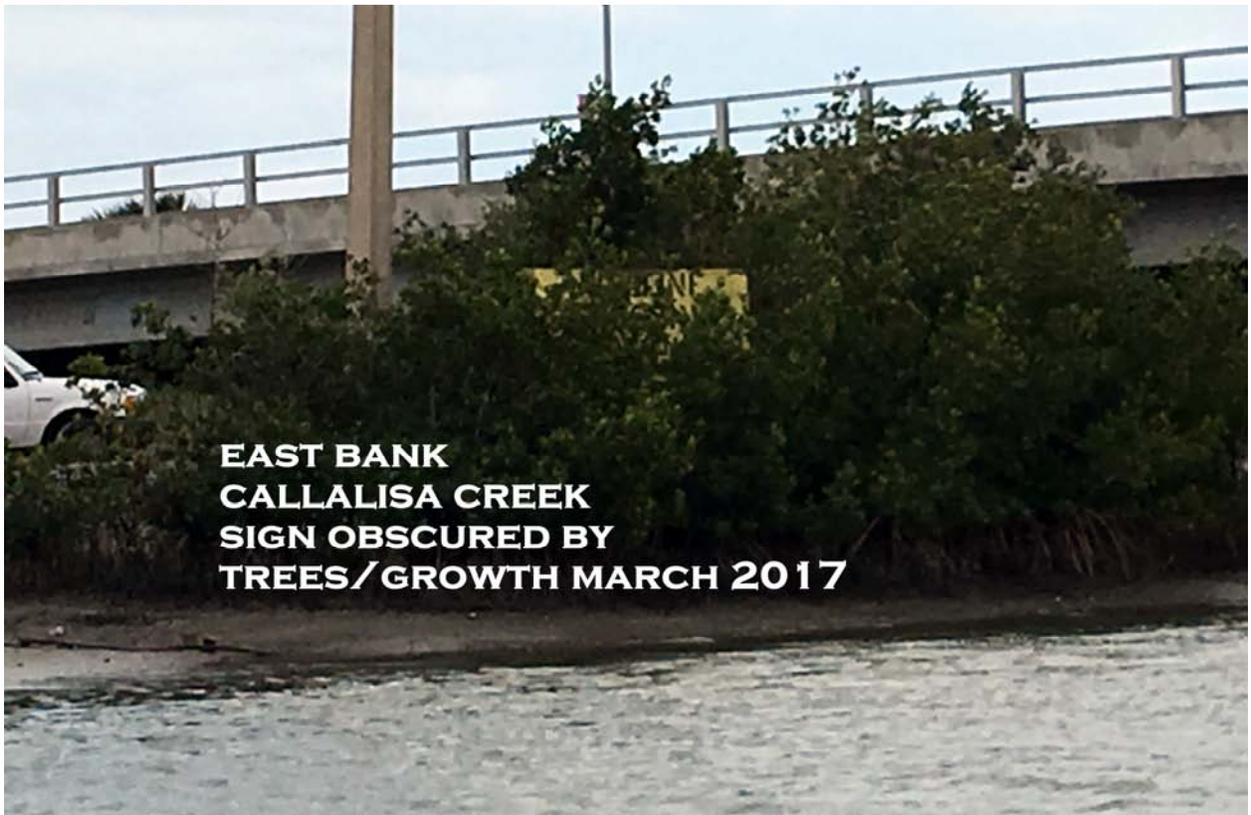
**EAST BANK  
CALLALISA CREEK  
SIGN OBSCURED BY  
TREES/GROWTH MARCH 2017**
