LOGAN DIVING & SALVAGE

POST INCIDENT
UNDERWATER INVESTIGATION
INTRACOASTAL WATERWAY
SUBAQUEOUS WATER MAIN CROSSING
FOR
UTILITIES COMMISSION NEW SMYRNA BEACH
JANUARY 18, 2018

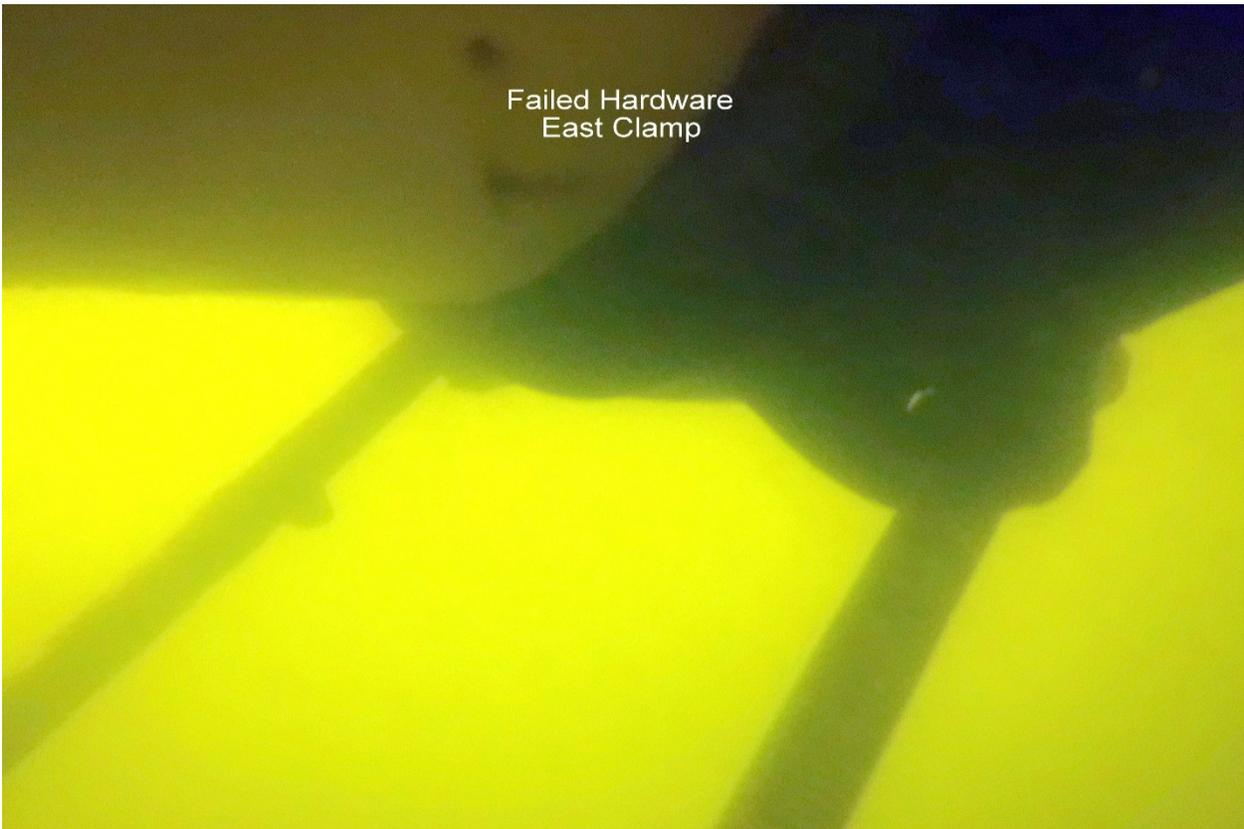
THE DIVER NOTED THE PRESENCE OF FAILED HARDWARE ON THE EAST CLAMP. THE FAILED HARDWARE WAS NOTED ON ALL SIDES OF THE CLAMP AND INCLUDED 1 MISSING BOLT AND 6 FAILED EYELETS. 4 OF THE 8 BOLTS APPEAR TO STILL BE INTACT.

Failed Hardware
East Clamp

- 1) APPLY FOR USACOE PERMITS (EMERGENCY BASIS) TO INSTALL CEMENT RIP RAP BAGS ABOVE AND BELOW THE PIPE TO PROVIDE SUPPORT, IMMOBILIZATION, AND PROTECTION.
- 2) SUPPORT THE PIPELINE AT EACH JOINT INITIALLY VIA THE CEMENT BAG METHOD IN PIERS.
- 3) REMOVE FAILED CLAMP/S. REALIGN PIPE SECTIONS AND INSTALL NEW CLAMPS AND SPOOL PIECE.
- 4) PROVIDE SUPPORT, IMMOBILIZATION, STABILIZATION, AND PROTECTION VIA THE CEMENT BAG METHOD TO ALL SECTIONS OF PIPE SUSPENDED AND EXPOSED.
- 5) INSPECT ALL CITY OWNED UNDERWATER UTILITIES CROSSINGS IN THE AREA TO DOCUMENT CURRENT EXISTING POST INCIDENT CONDITIONS.
- 6) DOCUMENT ALL HURRICANE IRMA RELATED DAMAGE TO CITY SUBAQUEOUS UTILITIES/ASSETS.
