**Utilities Commission
City of New Smyrna Beach, Florida**

**Assessment of Existing Reciprocating
Electrical Generation Equipment
- Final Report -**

**Smith Street and Swoope
Generating Facilities
(Project No. 306.021)**

July 29, 2011

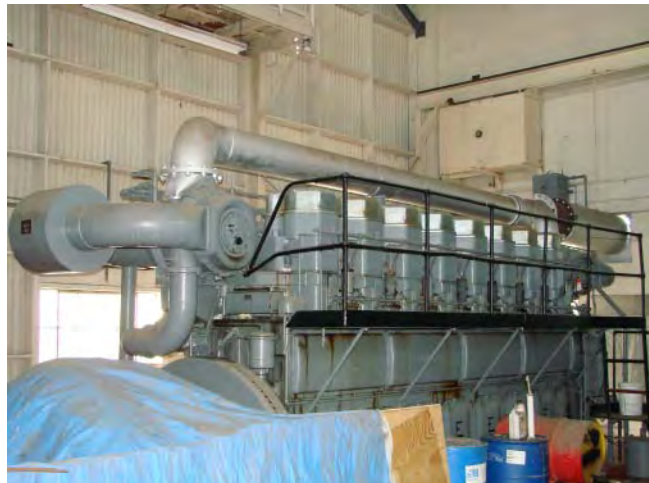
Description: Engine manufactured by Enterprise Engine, a company owned by Transamerica Corporation during the time this unit was built. The Enterprise division was later sold to Cooper Industries and remains part of that group today. This unit is an 8 cylinder model with turbo, 2532 Bhp at 360 RPM per nameplate data. UCNSB maintenance staff reports this engine underwent a major rebuild in late 1970s to early 1980s timeframe. The cost associated with that overhaul was approximately \$250k. Unfortunately, the generator is not in good operating condition and needs to be rewound, (again according to UCNSB maintenance staff). As a result, though this engine may be in good condition mechanically, operating records indicate no significant amount of run time for at least

the previous five years, perhaps much longer. The cylinder heads and valve covers are coated with a considerable amount of dust and a noticeable amount of what appeared to be mouse droppings. It is clear this engine has not been run for some time.

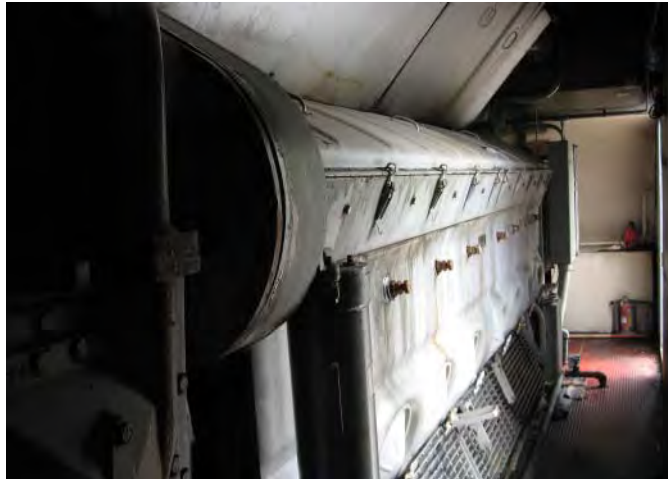
Description: Engine manufactured by the Electro-Motive Diesel division of GM. This unit is a 16 cylinder model with turbo, approx. 2800 Bhp at 720 RPM. UCNSB classifies this engine as a “peaking unit.” It is fully contained in a stand-alone enclosure which houses the engine-generator, a fan-cooled radiator unit, air intake, and a shrouded overhead exhaust silencer. This unit is capable of remote start. Three unsuccessful attempts results in a system control fault, disabling the remote start feature. UCNSB maintenance staff reports this engine had been rebuilt sometime in the 1980s and is currently in running condition today. Facility operating records indicate no runtime since calendar year 2008. Overall this engine appears sound with all components seemingly in place and functioning with the exception of the starting motor. The condition of the generator for this unit is reported to be good.

Discussion: Having been rebuilt within the past 25 years or so and under the presumption of minimal runtime during the past several years, there is no reason to conclude this engine is not in good, sound operating condition. That stated, we were made aware of the fact that there are at least two issues with this unit that prevent it from running if needed. First, the cooling fan sustained considerable damage during operation sometime in the recent past. As a result of some incident which is not fully understood, some of the fan blades were severely damaged during operation and remain so at the present time, (see photo). The damage has rendered this unit inoperable until and unless the fan is replaced.

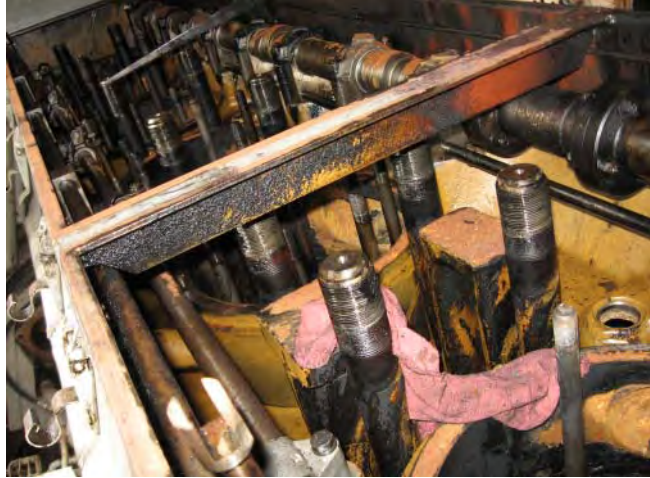
Description: Engine manufactured by the Electro-Motive Diesel division of GM. This unit is a 16 cylinder model with turbo, approximately 2800 Bhp at 720 RPM. UCNSB classifies this engine as a “peaking unit.” It is fully contained in a stand-alone enclosure which houses the engine-generator, a fan-cooled radiator unit, air intake, and a shrouded overhead exhaust silencer. This unit is capable of remote start. Three unsuccessful attempts result in a system control fault, disabling the remote start feature. Apparently, some time ago, this engine seized during a startup sequence. UCNSB main-

tenance staff began to disassemble the engine to determine the problem and presumably to make the needed repairs. During our visit, we found the valve covers off of one side of the engine, heads removed from the other, a main pump drive detached (see photo), and the shrouding removed from the exhaust manifold. For reasons not entirely understood, work on this unit was suspended and has not resumed. Facility operating records indicate no runtime for at least the previous five years. The condition of the generator for this unit is reported to be good.

Discussion: Though this engine could probably be made to operate again, it is doubtful it ever will. To repair and rebuild an engine of this size is an enormous effort, requiring considerable more resources and manpower than is currently available at UCNSB. In addition, it also seems that the enclosure on this unit may be allowing rainwater to leak down on the exhaust silencer, the exhaust manifold and eventually onto the engine itself, (see adjacent photo). Not that this concern is an overwhelming one, but it may have created some other problems with this unit that are not yet realized.

Remarks: We estimate the overall cost to repair this unit and return it to an operable condition would likely exceed \$1M inclusive of the costs associated with bringing this unit into EPA compliance and new engine controls. It seems overwhelmingly evident that this would not be money well spent, so effectively, this unit has already reached the end of its useful service life here at this facility.

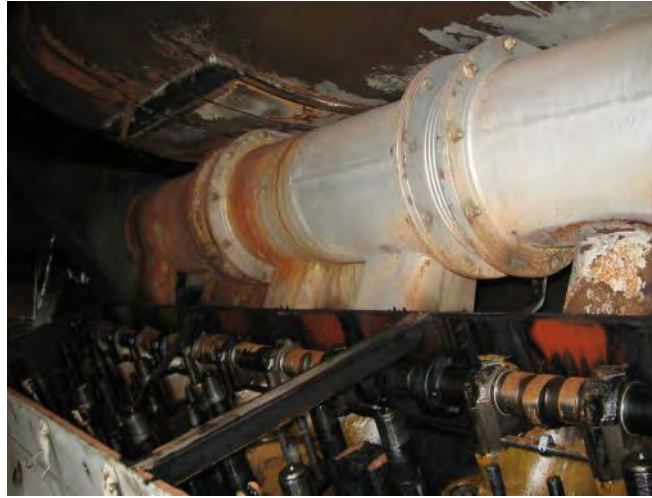
As was the case for Engine #9, the exhaust silencer would need to be replaced with a combination catalyst-silencer unit to meet the new RICE regulations. This presents some retrofit problems given the manner in which the existing silencer is shaped and fitted into the enclosure. Again, this is not an insurmountable issue, but one to keep in mind in this situation. As presented in the discussion section for Engine #9, there is also the issue with the transformer associated with the switchgear that prevents operation of any of the three EMD units.

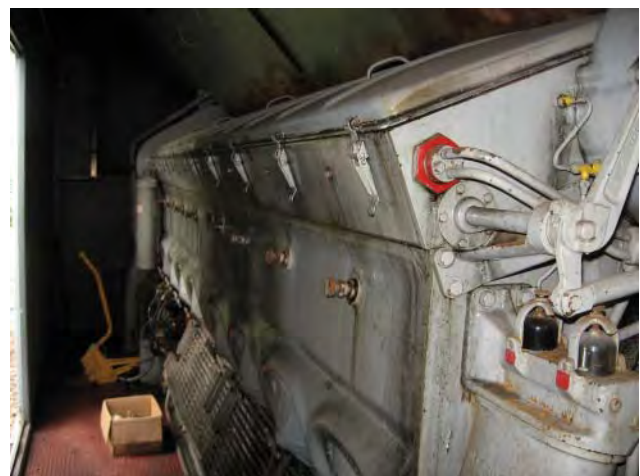
Description: Engine manufactured by the Electro-Motive Diesel division of GM. This unit is a 16 cylinder model with turbo, approx. 2800 Bhp at 720 RPM. UCNSB classifies this engine as a

“peaking unit.” It is fully contained in a stand-alone enclosure which houses the engine-generator, a fan-cooled radiator unit, air intake, and a shrouded overhead exhaust silencer. This unit is capable of remote start. Three unsuccessful attempts results in a system control fault, disabling the remote start feature. UCNSB maintenance staff reports this engine is also seized. To date, no resources have been expended in an attempt to determine the location and extent of the problem. Facility records indicate no runtime for this unit since calendar year 2006. It is believed the engine seized shortly after the last significant run sometime during 2006. The condition of the generator for this unit is reported to be good.

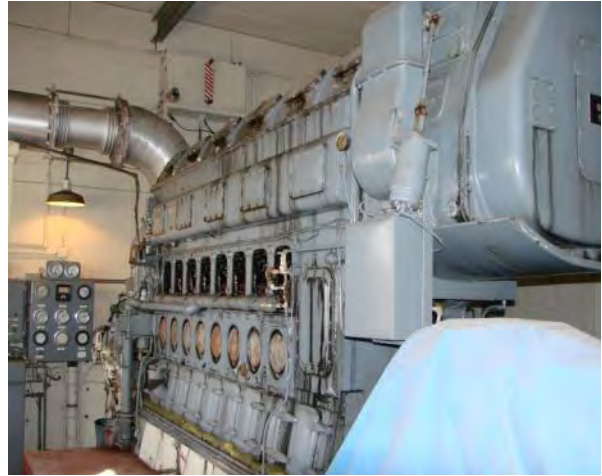
Description: Older model Fairbanks-Morse opposed-piston, 8 cylinder engine with blower, 1260 Bhp rating at 720 RPM. UCNSB maintenance staff reports this engine has not been started at all within the past three years. Facility operating records indicate no significant runtime in the previous five years. Though this engine may have had an original output rating of 910 kWe, UCNSB maintenance staff indicates they only operate it at about 600 kWe, approximately 65% output. We found the engine to be intact with all components seemingly in place and functioning. The condition of the generator for this unit is reported to be good, but it should be cleaned and tested prior to any extensive runtime.

Discussion: Despite the fact that this engine seems to be in good condition externally, perhaps the best indication we have of its actual condition is based on the reduced output from sustained operations several years ago. Though the engine may be capable of more than 65% output, we suspect the operating staff at this facility had good reasons for not pushing this engine for more. That coupled with the overall age of the engine and the fact that it has probably not been turned-over in at least three years are strong indications that some mechanical work is necessary to return this unit to its fully reliable operating condition.

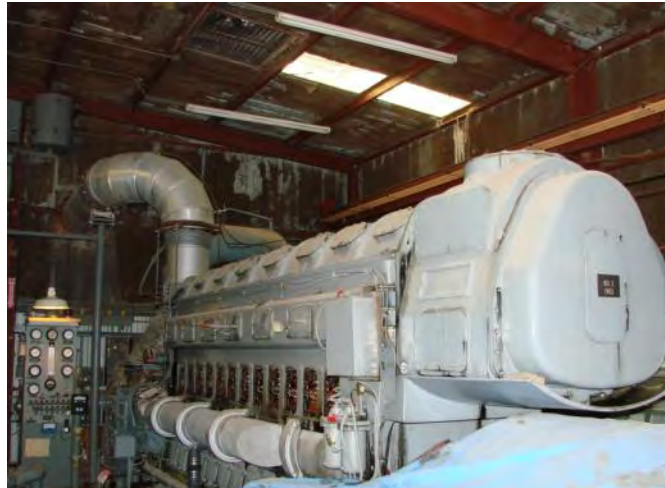
Description: Fairbanks-Morse opposed-piston, 12 cylinder engine with turbo-blower, 3360 Bhp rating at 720 RPM, and is equipped with a charge air cooler. Facility operating records indicate this ran most recently in calendar year 2010 for a total of two hours. The greatest amount of runtime within the past five years occurred in 2007. During that year, this unit was operated for a total of eleven hours. UCNSB maintenance staff indicates they operate engine at 2050 kW output, approximately 85% of nameplate rating. We found this engine to be intact with all components seemingly in place and functioning with good outward appearance. The condition of the generator for this unit is reported to be good.

Discussion: Overall this engine appears to be in good condition. But without the benefit of any diagnostic tests, we can only speculate as to its internal condition and that of its main components. For an engine of this vintage, an 85% output for its most recent sustained still seems strong, thus it remains potentially viable for future service in this power plant. The engine's perceived condition along with the availability of replacement parts and good technical support from the OEM further supports this.

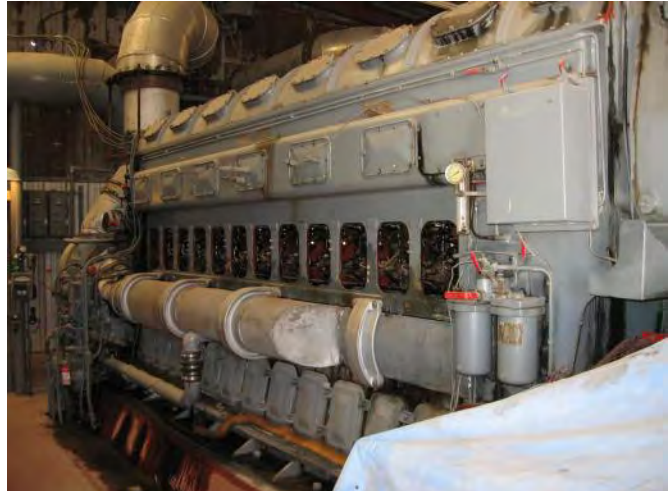
Description: Fairbanks-Morse opposed-piston, 12 cylinder engine with turbo-blower, 3360 Bhp rating at 720 RPM, and is equipped with a charge air cooler. Facility operating records indicate only very few runtime hours within the previous five years. UCNSB maintenance staff indicates they operate engine at 2275 kWe output, approximately 95% of nameplate rating. We found this engine to be intact with all components seemingly in place and functioning with very good outward appearance. The condition of the generator for this unit is reported to be good.

Discussion: A 95% output for a sustained run for an engine of this vintage seems to be a good indication of the overall condition of the engine itself. Though this engine perhaps never figures to be a major part of the overall energy or capacity needs for this utility, it seems that it still has potential for additional service here. Clearly, it should be ‘exercised’ more often than has been the case recently to remain a viable unit for power generation. Again, we would claim that support for this engine from the OEM would be more than satisfactory.
